Manhole Inspection Summary

Manhole # S21K__039MH

Location Address: **215 MONROE ST**

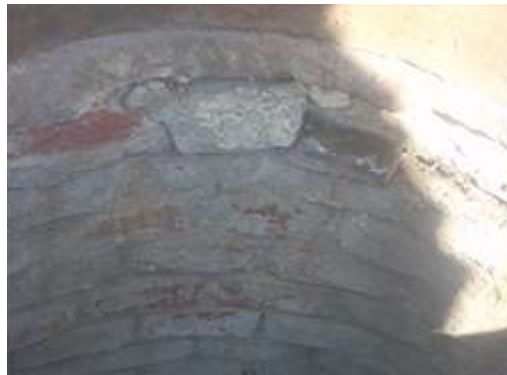
Defect 3

Condition: ☐ Sound ☐ Cracked ☐ Root Intrusion ☐ Loose Brick ☒ **Deteriorated**

CORBEL DETERIORATION

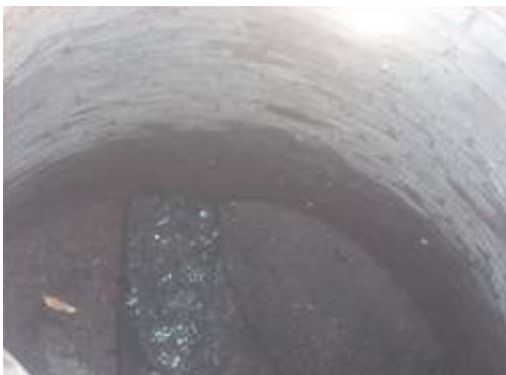
Defect 2

BARREL INFILTRATION

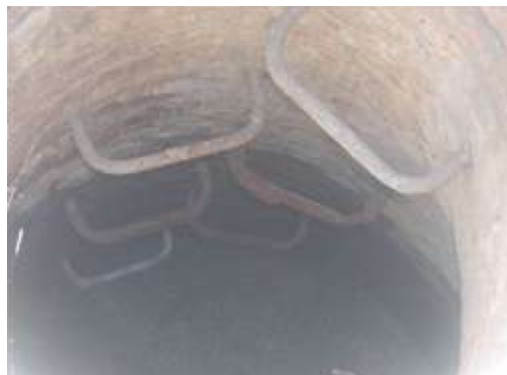
Defect 1

Steps Count: **7** Missing: **0** ☒ **Corroded**

CORRODED STEPS

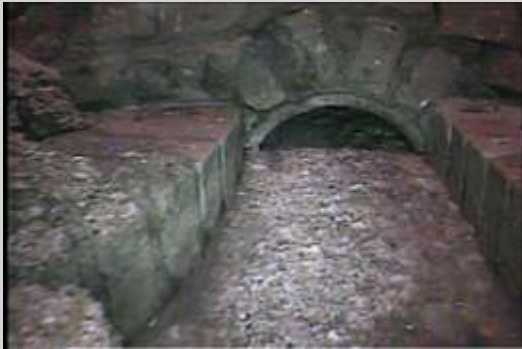
12 O'Clock Outflow

8 in. Circular Gravity Sewer
Pipe Out @ 12 O'Clock

Pipe Height: **8.4** (in.) Rod and Bar (Angled)
Pipe Material: **Clay** ☐ Pipe Lined
Invert Depth: **9.81** (ft.) Flow Characteristics: **Slow**
Deposits: ☐ None ☐ Mud ☐ Sludge ☒ **Debris** ☐ Grease
Silt Depth: **4** (in.) Deposits Extent: **Medium**
Infiltration: **None** Pipe Seal Cond: **Sound**

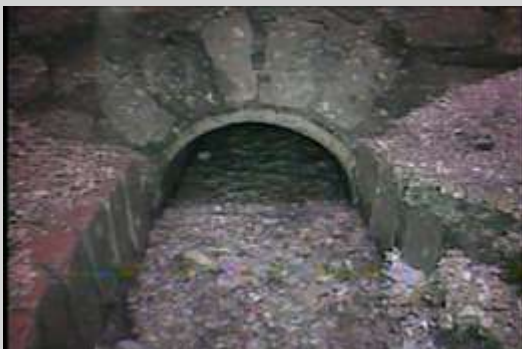
9 O'Clock Inflow

8 in. Circular Gravity Sewer
Pipe In @ 9 O'Clock

Pipe Height: **8.4** (in.) Rod and Bar (Angled)
Pipe Material: **Clay** ☐ Pipe Lined
Invert Depth: **9.59** (ft.) Flow Characteristics: **Slow**
Deposits: ☐ None ☐ Mud ☐ Sludge ☒ **Debris** ☐ Grease
Silt Depth: **3** (in.) Deposits Extent: **Medium**
Infiltration: **None** Pipe Seal Cond: **Sound**
